***Chester, PA
Chemical Plant***

***CCTV
Report***

*Prepared
May 6, 2013*

Street123 City Loc. details Location Code	COVERT SLUICEWAY Easement/Right of Way	Use of Sewer Drainage Area Flow Control Length surveyed	Stormwater 74.00 ft	Upstream MH Downstream MH Dir. of Survey Section Length	COVERT OPENING END Downstream 74.00 ft
Purpose of Survey Year Laid Year Rehabilitated Tape / Media No.	Routine Assessment MOBILE-1	Joint Length Dia./Height Material Lining Method		60 inch Concrete Pipe (non-reinforced)	
Add. Information :	UNDER RAIL RD CROSSING

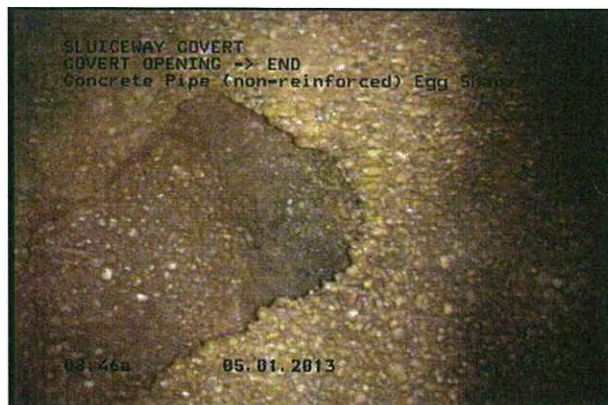
Hole Void Visible, at 12 o'clock, within 8 inches of joint: NO

Photo: 1_65_01052013_085948__A.JPG, VCR No.: MOBILE-1
65FT, Hole Void Visible, at 12 o'clock, within 8 inches of joint: NO

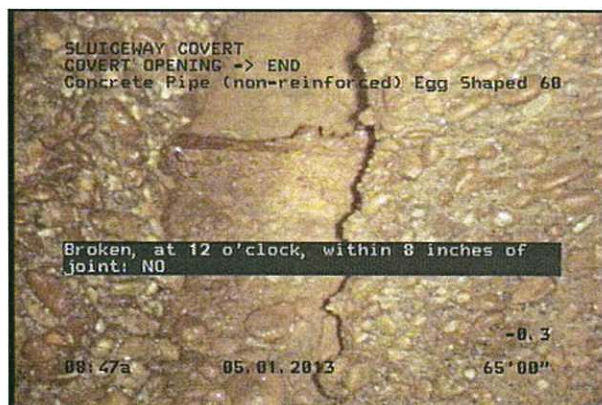
Broken, at 12 o'clock, within 8 inches of joint: NO

Photo: 1_65_01052013_090105__A.JPG, VCR No.: MOBILE-1
65FT, Broken, at 12 o'clock, within 8 inches of joint: NO

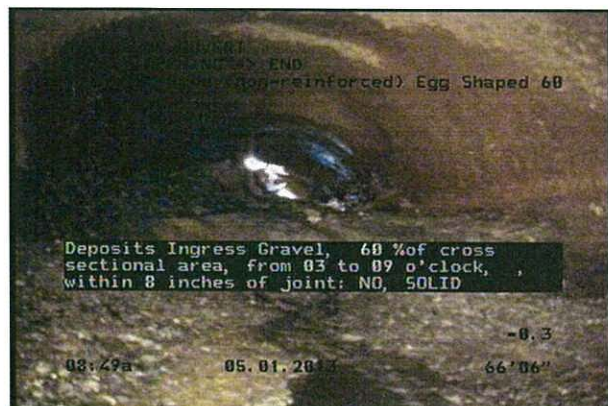
Deposits Ingress Gravel, 60 %of cross sectional area, from 03 to 09 o'clock, , within 8 inches of joint: NO / SOLID

Photo: 1_66.5_01052013_090329__A.JPG, VCR No.: MOBILE-1
66.5FT, Deposits Ingress Gravel, 60 %of cross sectional area, from 03 to 09 o'clock, within 8 inches of joint: NO

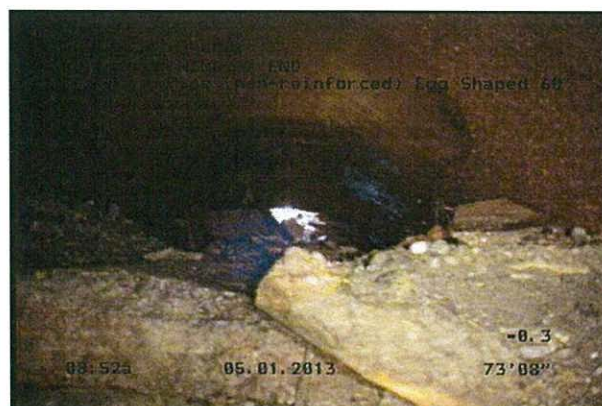
Collapse Pipe Sewer, 80 %

Survey Abandoned / AT COLLAPSE

Photo: 1_73.7_01052013_090603__A.JPG, VCR No.: MOBILE-1
73.7FT, Collapse Pipe Sewer, 80 %
